Pump Repair and Well Reconstruction Saves Money and Increases Water Production

Arlington Heights, Illinois

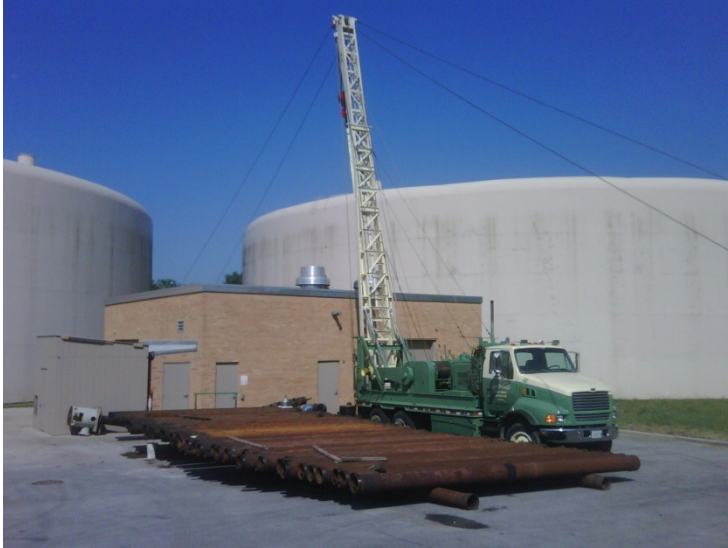
Layne used a pump service rig to remove an oil lubricated pumping assembly set to a depth of 1,000 ft. and weighing 80,000 lbs.
